## CASE REPORT(S): UNCOMPLICATED CROWN FRACTURES

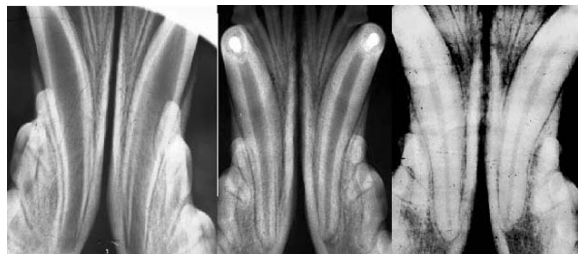
The lower canines of a German short haired pointer at 6, 14 and 32 months of age. Note how the pulp chambers got smaller and the walls of the tooth grew thicker over time.

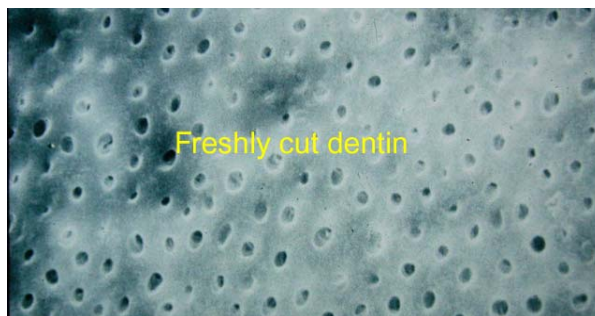
Freshly cut dentin surface showing the open dentin tubules. While these pores are very small, they are larger than bacteria and so can act as open pathways for bacteria to gain entry to the pulp chamber inside the tooth.

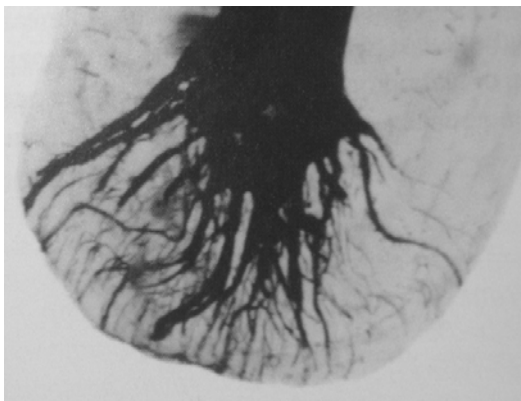
An apical delta stained with India ink. These delta channels are too small to be seen radiographically.

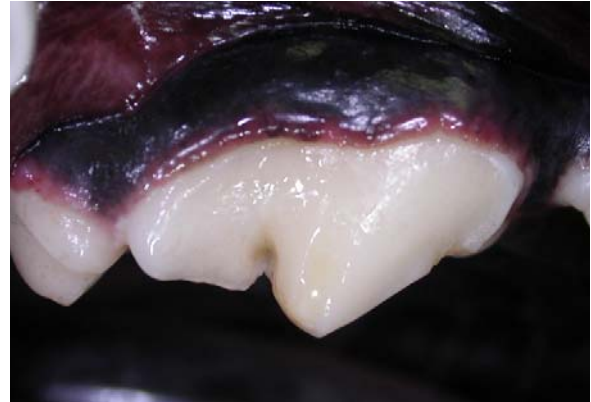
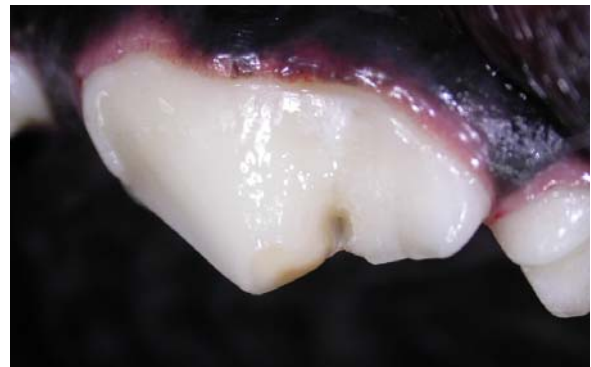
I first saw Breeze in October of 2008 (just over four years of age) for assessment of uncomplicated crown fractures of the right and left upper 4<sup>th</sup> premolar teeth.

These were quite superficial fractures, but I have seen such damage result in septic pulp necrosis as shown in the following three examples.

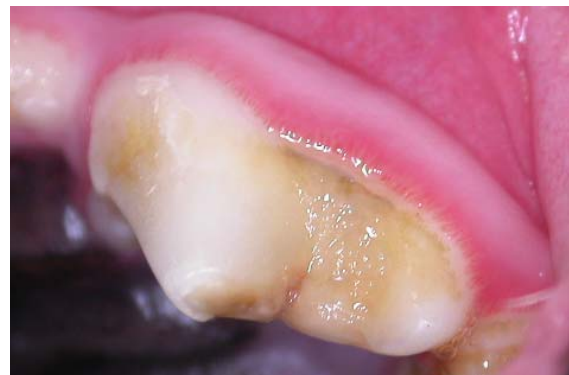
Not much damage to the crown or anything visually to suggest endodontic disease...

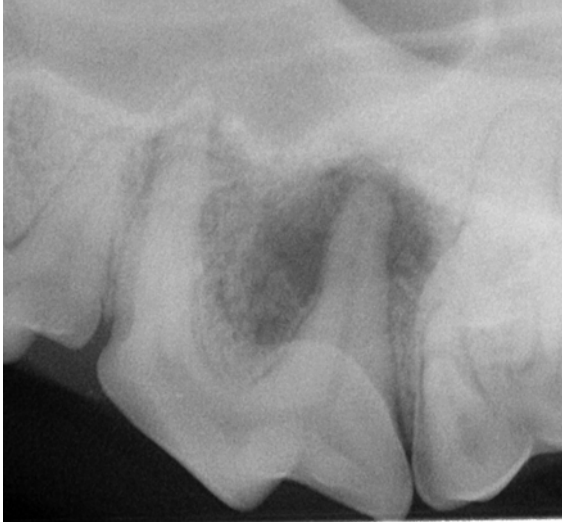
...but radiographically, there is massive bone loss around all three root tips indicating chronic infection.

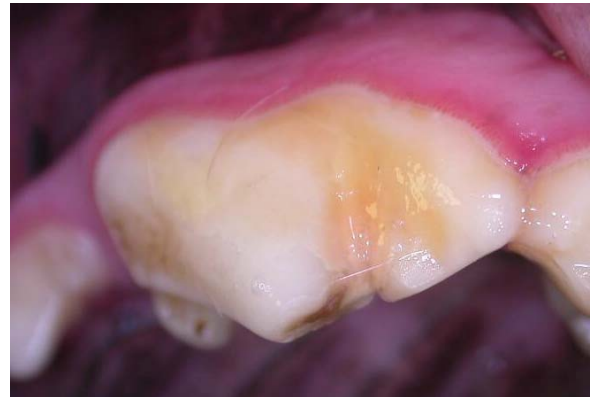
And finally, here is the left upper 4<sup>th</sup> premolar of a 5.5-year-old golden retriever with very superficial damage...

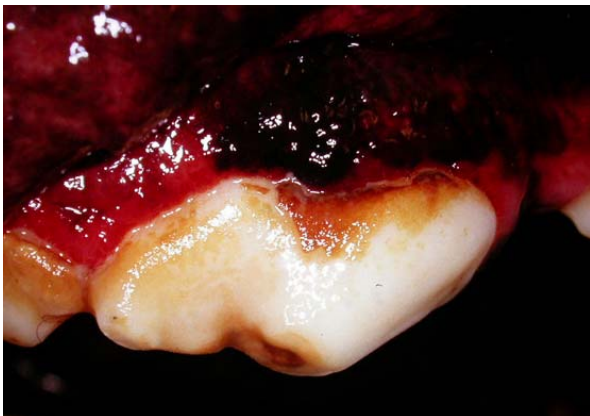
...but very obviously the victim of septic pulp necrosis and chronic periapical periodontitis.

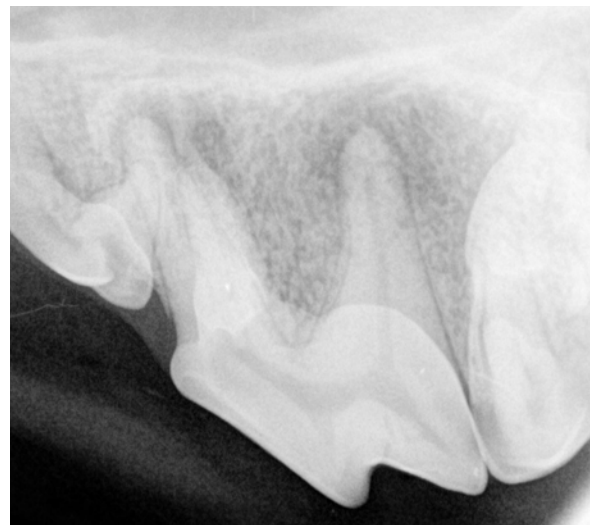
Again, pretty unimpressive damage to the right upper 4<sup>th</sup> premolar...

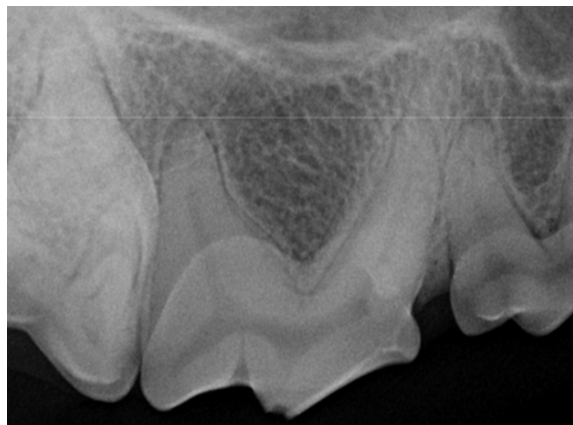
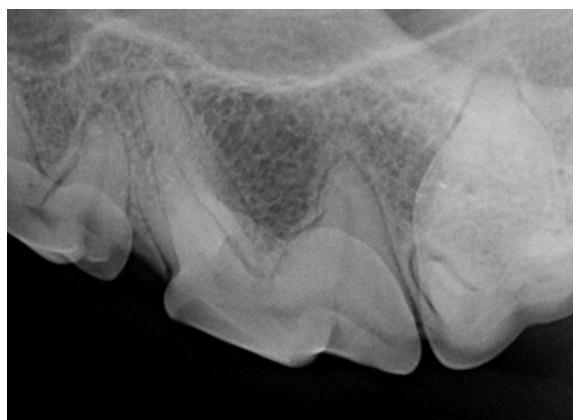
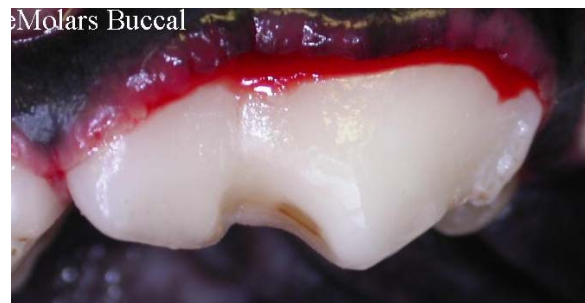
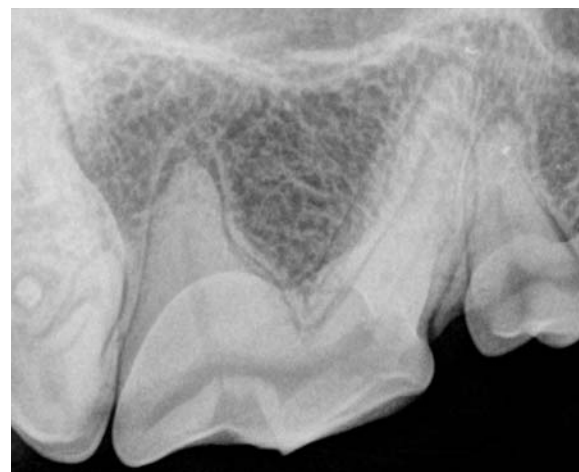
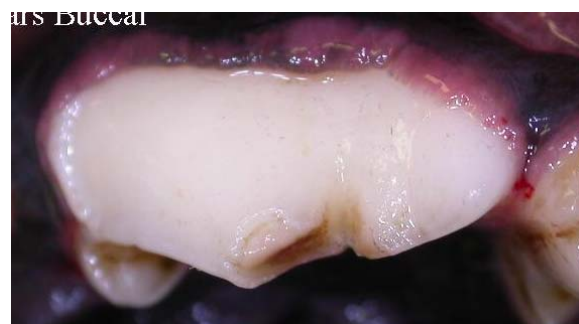
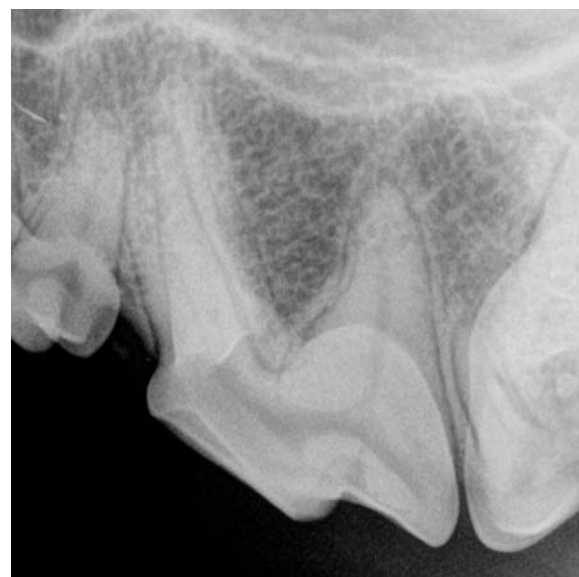
Now, back to Breeze. Knowing that superficial coronal damage does have the potential to allow bacterial ingress through the porous dentin, resulting in septic pulp necrosis and apical periodontitis, Breeze was admitted for a detailed examination including whole mouth intra-oral dental radiographs, transillumination etcetera.

And I could find no clinical or radiographic evidence of endodontic disease at that time. The transillumination suggested blood flow through the crown of the tooth meaning the pulp was alive then, but this does not mean it was healthy. There was insufficient evidence of pulp pathology to warrant extraction or root canal treatment at that time, but this is no guarantee that endodontic disease would not develop in the future. So, treatment involved a thorough oral hygiene procedure followed by coating the fracture sites with a fluoride-releasing bonding agent to seal the exposed dentin tubules and offer some protection for the underlying pulp tissue. Then we planned to see Breeze again a year or so later for follow-up.

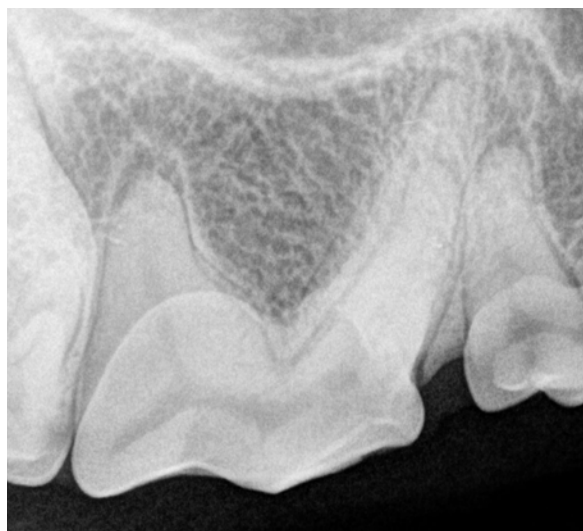
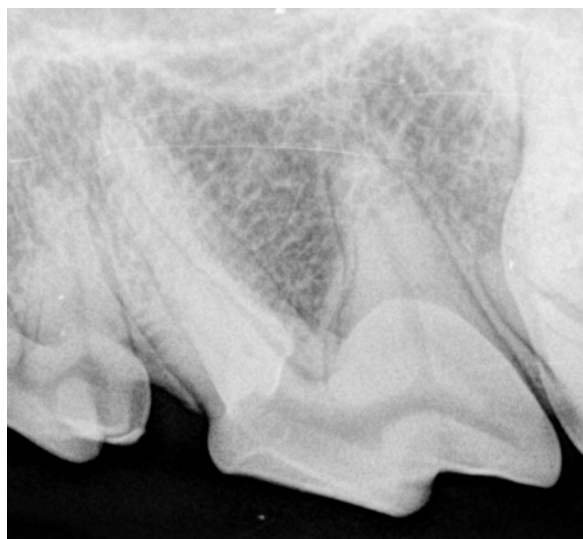
Radiographically, I think they are still doing well.

Transillumination also showed no signs of trouble. No treatment for these teeth this year. But Breeze always has something going on and this year it was the lower right 1<sup>st</sup> molar.

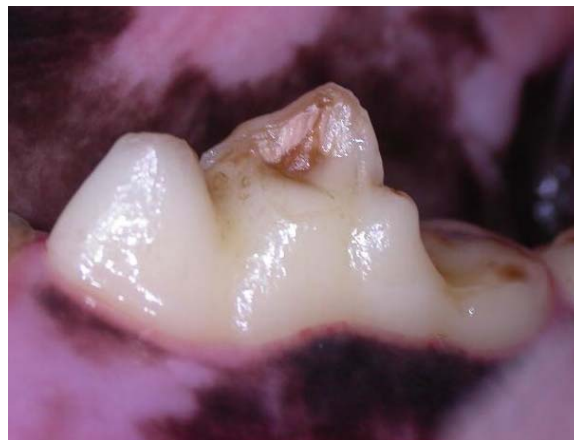
Here is a pre-op photograph from the lingual aspect showing a significant uncomplicated crown fracture. Fortunately, I had prior year's radiographs as a baseline and here they are. The first is from October, 2008 and the second from March 2010.

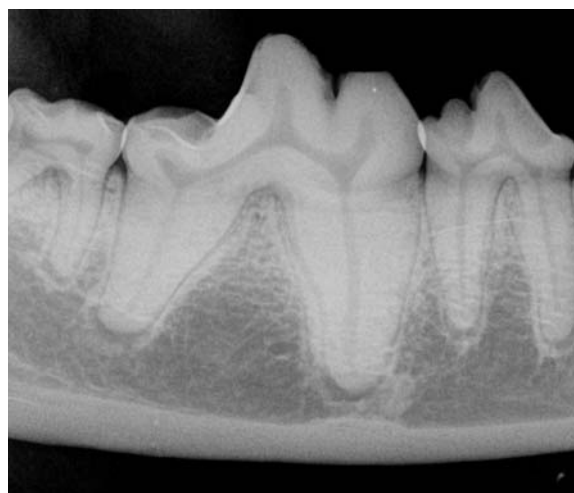
In those images we can confirm that there was no significant damage to the crown of the tooth at prior visits and that the chevron signs have been there and unchanged for some years (ie normal for this dog). Even the little density mesial to the tip of the mesial root has been there for a long time without change (again, likely of no significance). Below is this year's radiograph showing the obvious coronal damage but otherwise, no changes to indicate endodontic disease.

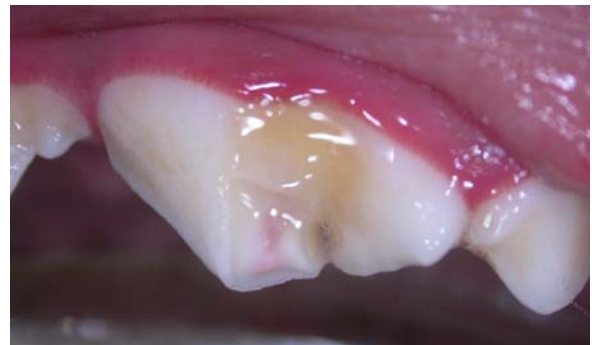
In another case, a 1.5-year-old Australian kelpie was presented with an uncomplicated crown fracture of the left upper 4<sup>th</sup> premolar in which the evidence was that the pulp was alive but that the fracture was so close to the pulp (near pulp exposure) that it would likely not survive much longer without treatment.

Simply putting a bonding agent on the exposed dentin was not going to be enough protection for this tooth. And any solid restoration I might have bonded over the area as a bandage would have popped off within weeks. Restorations can do well in holes when surrounded by tooth tissue but do not last well in a dog mouth when simply glued on to an exposed surface. On the other hand, it was an immature tooth with vital pulp.

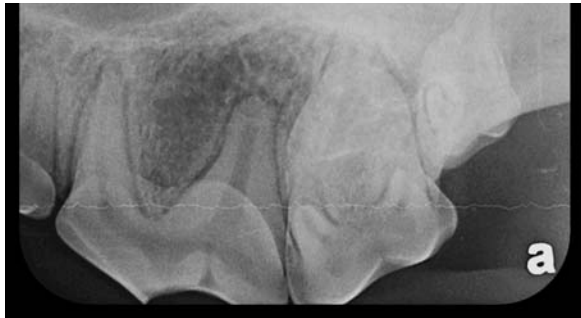
The immaturity meant (among other things) that the pulp chamber would be large and the wall of the tooth thin.

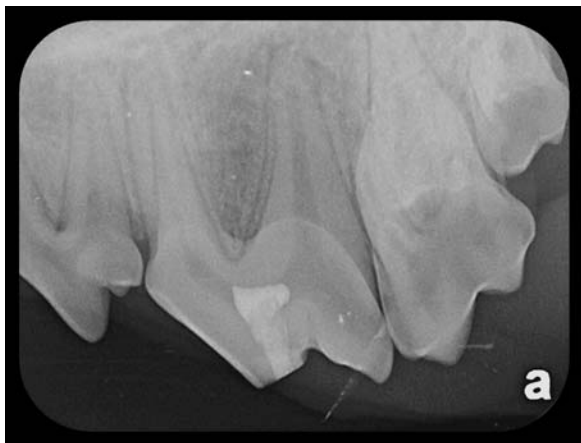
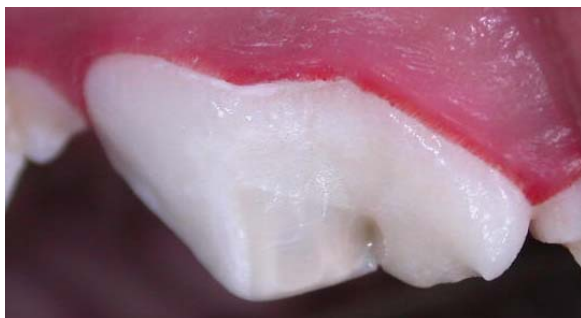
The images above were taken immediately post-op. The images in the next column were taken at follow-up eight months later.

I did not want to extract this tooth, I did not want to do root canal (total pulpectomy) on this tooth and I could not protect the pulp by gluing a restoration on to the exposed fracture site, so I did vital pulp therapy. I have done this procedure many times on single-root canine teeth but not often in multirooted teeth. None-the-less, it seemed the best option in this case and so we proceeded.

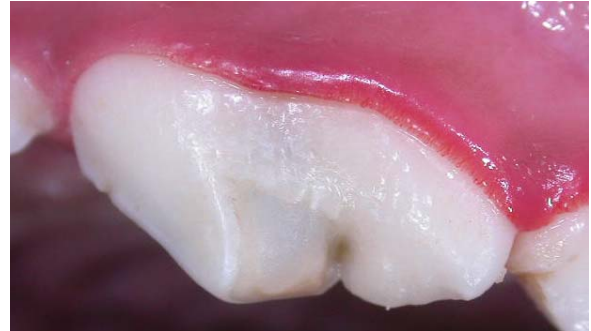
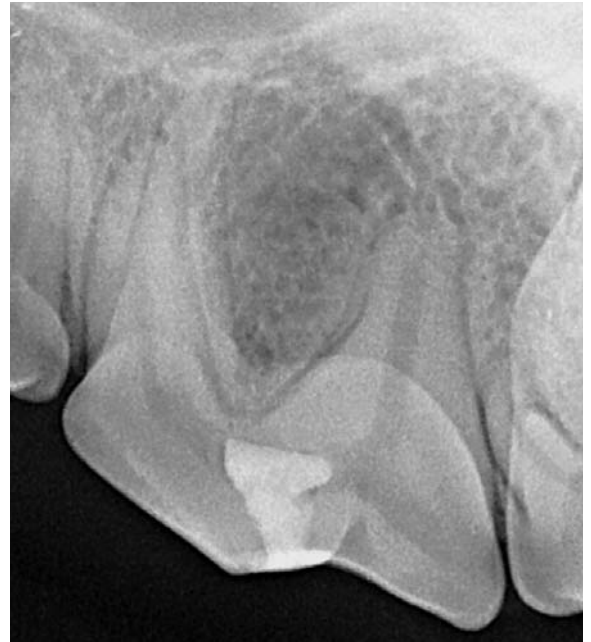
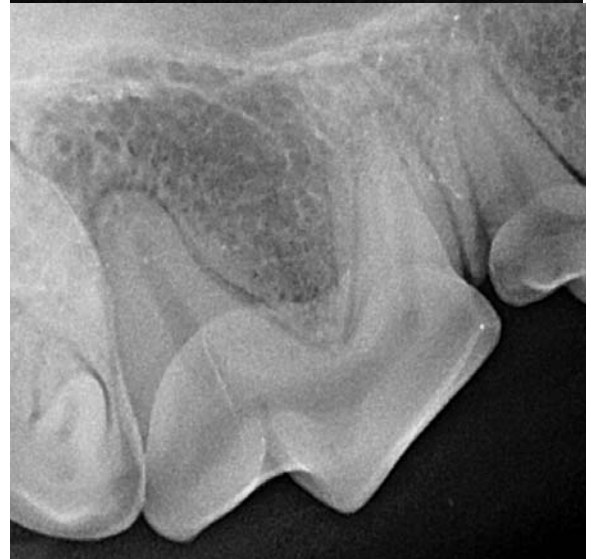
The pulp chambers are smaller than pre-op, the same size as the right 4<sup>th</sup> premolar and there are dentin bridges adjacent to the pulp capping material. As well, the tooth transilluminated well and there are no signs or periapical changes. All

indications are that the tooth survived the injury and the treatment and should do well in the long-run, providing the dog does no further damage to it.
